DAVID M. MILNER
dba
CERTIFIED SEPTIC INSPECTION
112 BEAVER POINT ROAD
SALT SPRING ISLAND, B.C.
V8K 1Y9
OFFICE 250-653-4636
CELL # 250-538-7477

JULY 27, 2014
OUR FILE #SSIHEADSTREET173

**RE: Performance Inspection of the Onsite Sewerage System at
173 Head Street, Salt Spring Island, BC.**

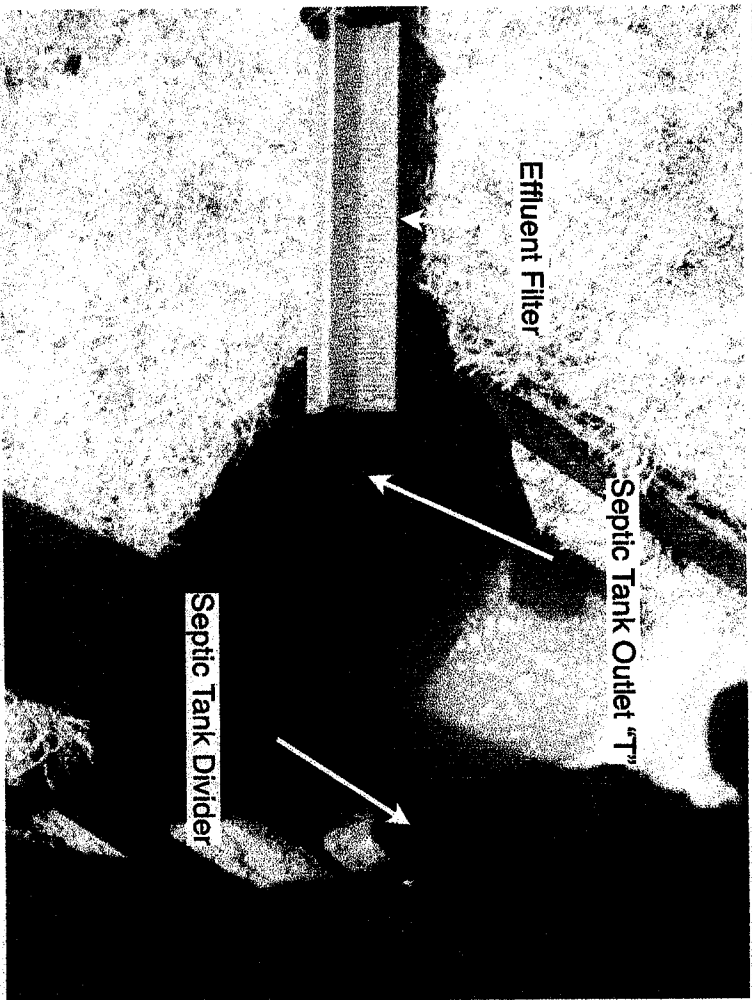
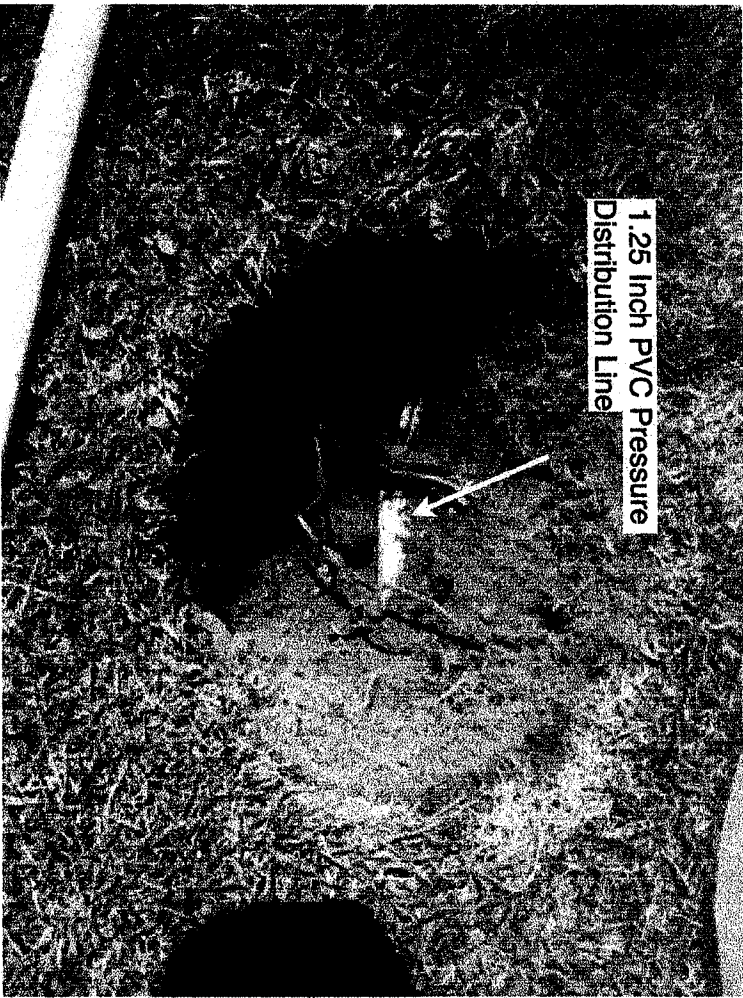
Please see attached photographs in regards to the system.

- Lids were removed to inspect tank's interior.
- Top scum layer is 4 inches. Liquid in the tank is 38 inches and there are 3 inches of solids at the bottom of the tank. The septic tank will need to be pumped out in approximately 2 years.

- The Pump Chamber lid was removed. The pump chamber is in good condition and the effluent pump is working.
- Effluent is pumped up a PVC pipe to the Absorption Field, located in a grassy area beside the path to the home.

- One of the four Pressure Distribution Lines was exposed and inspected. Minor roots were found in the drain rock and around the 1.25 inch PVC line.
- The septic field is in good condition.
